Arizona-Southern California Outages on September 8, 2011

Causes and Recommendations

Prepared by the Staffs of the
Federal Energy Regulatory Commission
and the
North American Electric Reliability Corporation

April 2012

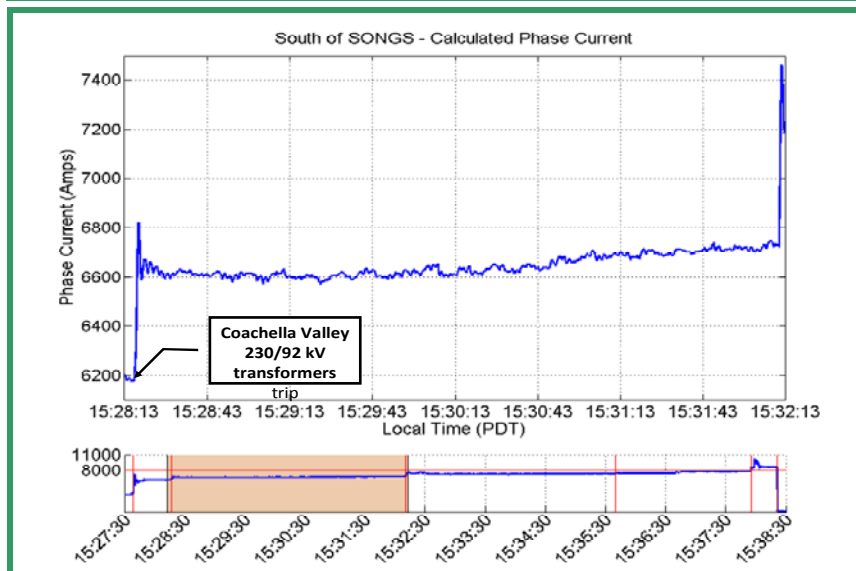
South of SONGS – Calculated Phase Current

15:28:17 – Two Coachella Valley 230/92 kV transformers and the Coachella Valley Ramon 230 kV “KS” line tripped. (030)

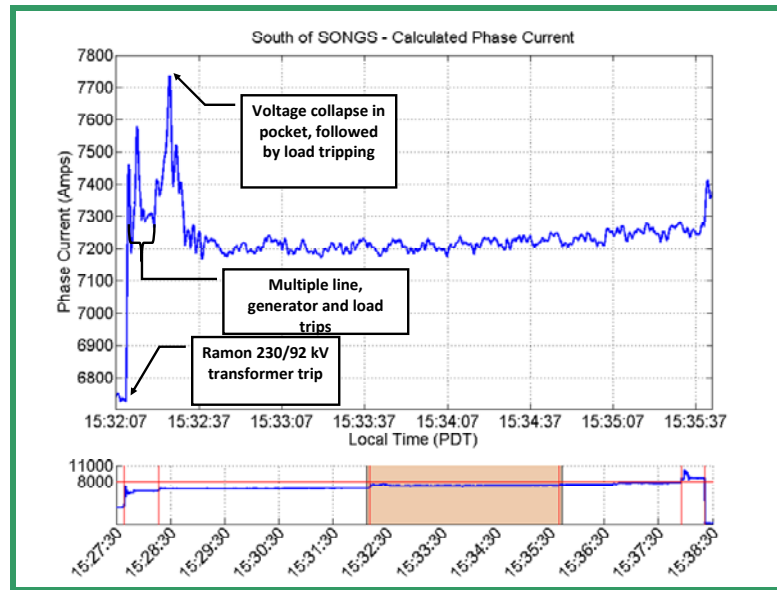
South of SONGS – Calculated Phase Current

Time: 15:32:10 – The Ramon 230/92 kV transformer tripped and IID shed 444 MW of load. (110)

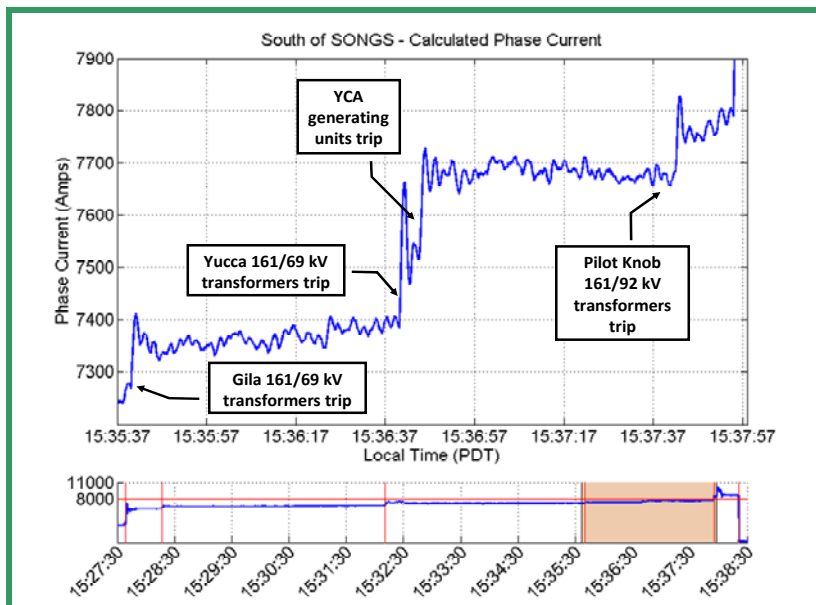
South of SONGS – Calculated Phase Current

Time: 15:35:31 – Yuma Cogen (YCA) tripped. (180)

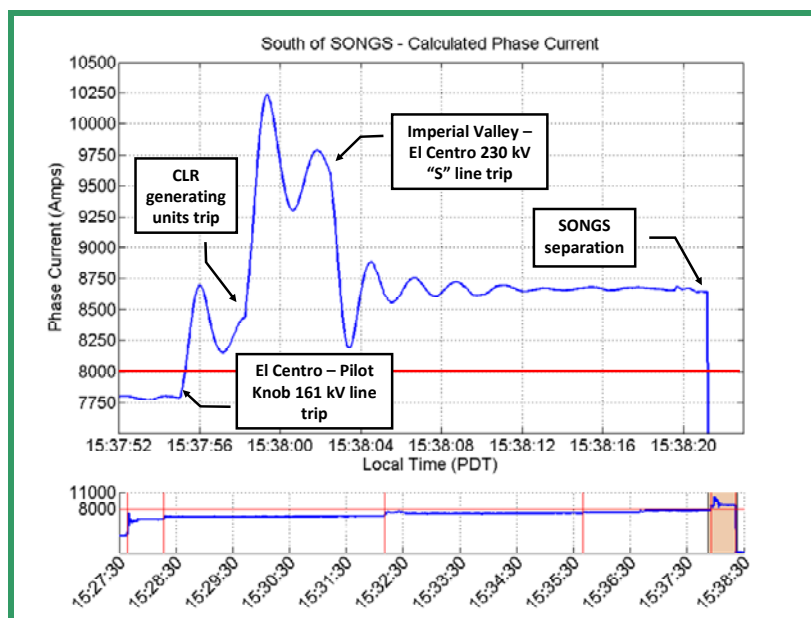
South of SONGS – Calculated Phase Current

Time: 15:37:55 – The El Centro-Pilot Knob 161 kV line tripped. (230)

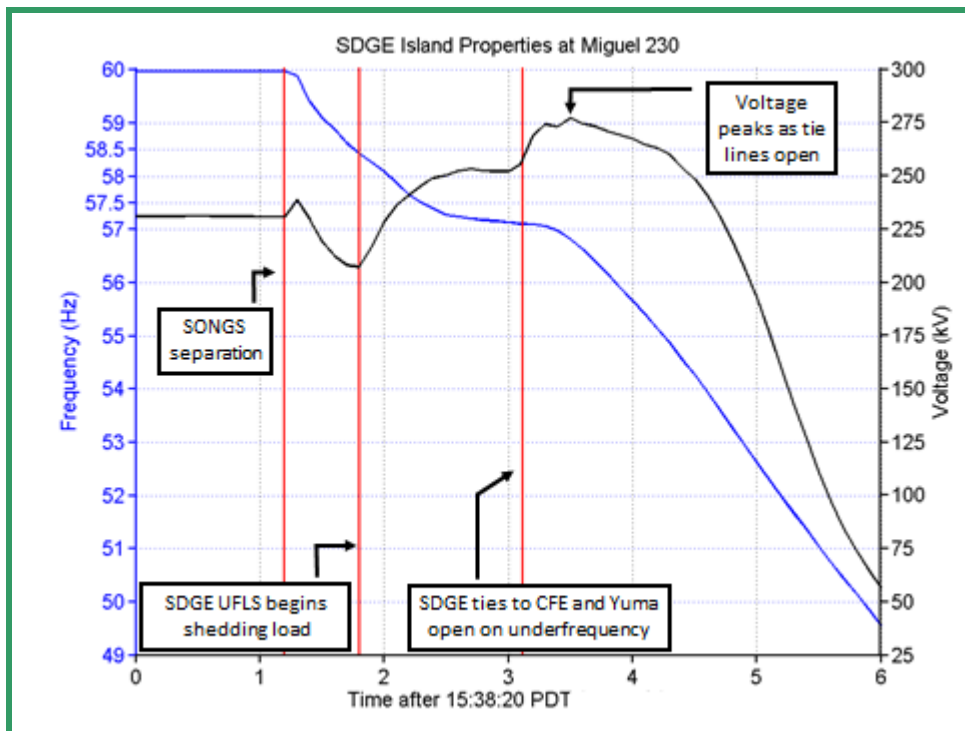
Figure 10: Frequency, Voltage in the SDG&E/Yuma/CFE Island

The SDG&E/CFE/Yuma island created by operation of the SONGS separation scheme had a significant imbalance between generation and load from the beginning. As a result, the frequency in the island rapidly declined. By less than a second after the SONGS separation scheme activated (15:38:22), the UFLS programs of SDG&E, APS, and CFE had all begun activating within the island. *Figures 10 and 11*, below show the frequency within the island as it collapses. All steps of the UFLS systems activated and system frequency in the island briefly stalled at approximately 57.2 hertz (Hz). CFE's UFLS analysis showed 512 MW of load shed by 15:38:21.901.

However, the same analysis showed that three CFE generators, totaling 459 MW, tripped offline beginning at 15:38:21.905, partially negating CFE's UFLS actions. In addition, a number of smaller generators, totaling about 130 MW, tripped only 0.5 seconds later while CFE was still connected to SDG&E and while SDG&E's UFLS program was still working to shed load.⁵⁴ See *Figure 11*, below. The net effect of CFE's UFLS actions and generator trips—512 MW shed by UFLS and 590 MW of tripped generation—was that CFE's imports from SDG&E increased from approximately 440 MW to approximately 520 MW. This worsened CFE's system conditions and increased the stress on SDG&E before SDG&E's underfrequency separation protection systems opened the ties between CFE and SDG&E. SDG&E also had three generators with underfrequency protection that operated at 57.3 Hz, above the frequency at which the system leveled out. Due to these early generation losses, the frequency continued to decline below 57 Hz, which was the underfrequency setting for the majority of generators in the island. Thus, the island blacked out, shortly after separating into three sub-islands.

⁵⁴ The fact that several generators tripped during load shedding suggests that CFE may benefit from analyzing whether its UFLS program and generator underfrequency protection systems are coordinated.

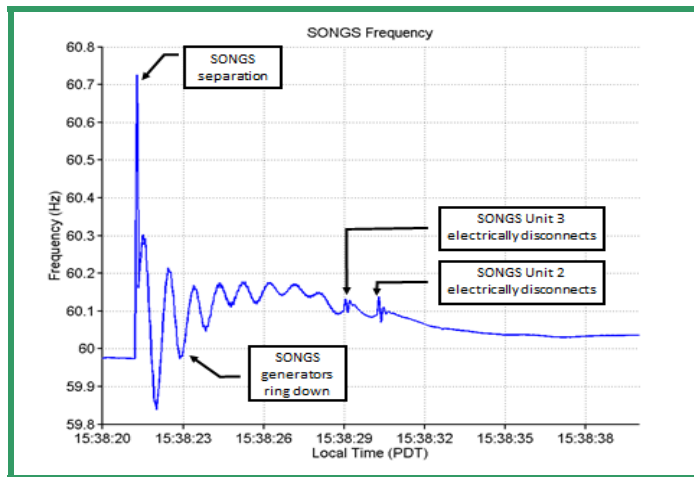
Figure 12 : Frequency Excursion in WECC Interconnection Immediately after the SONGS

shut down, at 15:38:30.209, SONGS Unit 2 electrically disconnected from the system. Loss of the 2,300 MW of SONGS' generation effectively reduced the loss of load for the main body of the Western Interconnection from a 3,400 MW loss to a net 1,100 MW load loss. This made the recovery from the resulting overfrequency event much easier. The SONGS generators did not lose offsite power because the SONGS switchyard was still connected to the SCE system.

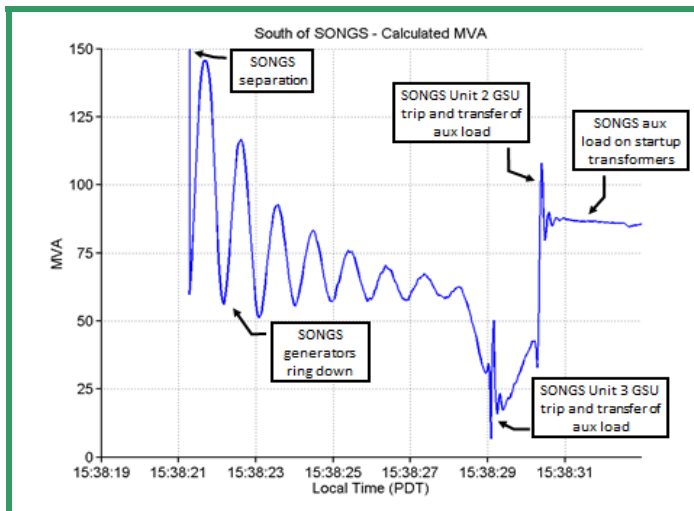
Figure 13: SONGS Generation Trips and Auxiliary Loads Transfer to 230 kV Bus

Although the SONGS generators remained connected to the SCE side of the switchyard at SONGS, at about 15:38:27.5, or approximately six seconds after the SONGS separation scheme initiated, the SONGS turbines both experienced a brief acceleration in speed and tripped due to turbine control logic. At the same time, local system frequency at SONGS was observed to spike from 59.974 Hz to 61.203 Hz. After the initial impulse caused by the system separation, the frequency in the main body of the Western Interconnection peaked near 60.170 Hz. This can be seen on Figures 12 and 13, on the next page. The turbine trip initiated a reactor shutdown, and the units began coasting down. A little more than a second later, at 15:38:28.963, SONGS Unit 3 electrically disconnected from the system, and less than three seconds after the reactors
